FACILITIES ASSESSMENT REPORT - VOL. 2

04.24.19

FORT ATKINSON MIDDLE SCHOOL

Re: Fort Atkinson Middle School
Follow-up Structural Condition Assessment of
Existing Concrete Pool Structure
AE Project No. 018-492

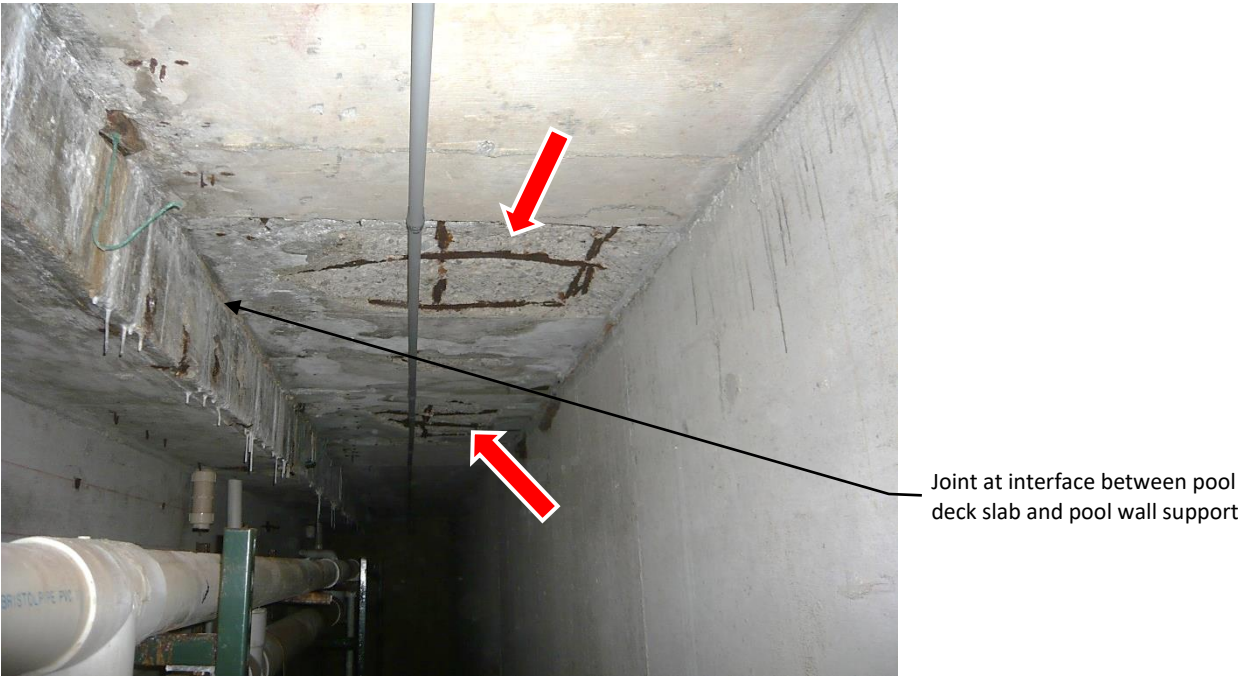
1. Spalled and delaminated (hollow sounding) concrete were observed as follows (Figures 2 through 6):
 - a. Underside of structural pool deck slab: approximately 200 to 300 square feet

Concrete deterioration in the form of spalls and delaminations exist throughout the exposed concrete surfaces of the pool deck and pool structure. Based on our experience with the investigation and assessment of similar concrete structures, observed deterioration is consistent with corrosion of the embedded steel reinforcement resulting from prolonged exposure to oxygen and chlorinated water infiltrating through the pool deck. When embedded steel reinforcement corrodes, it expands and occupies a volume larger than the original steel reinforcing. This expansion exerts stresses on the surrounding concrete that is typically relieved by cracking in a plane parallel to the concrete surface (delamination). Concrete spalls occur when the delaminated concrete completely debonds from the substrate leaving a void and exposing the corroded steel reinforcement.

Figure 2: Spalled concrete, with exposed corroded steel reinforcement, on the underside of the structural pool deck slab. Note efflorescence staining (white mineral deposits), an indication of previous and/or active water infiltration, along the length of the slab to pool wall support interface.

1. Repair deteriorated concrete on underside surfaces of the structural pool deck slab. Concrete repairs typically consist of removal of unsound and sound concrete, proper surface preparation of the exposed steel reinforcing bars and concrete surfaces, installation of supplemental steel reinforcement, and placement of a concrete patching material.

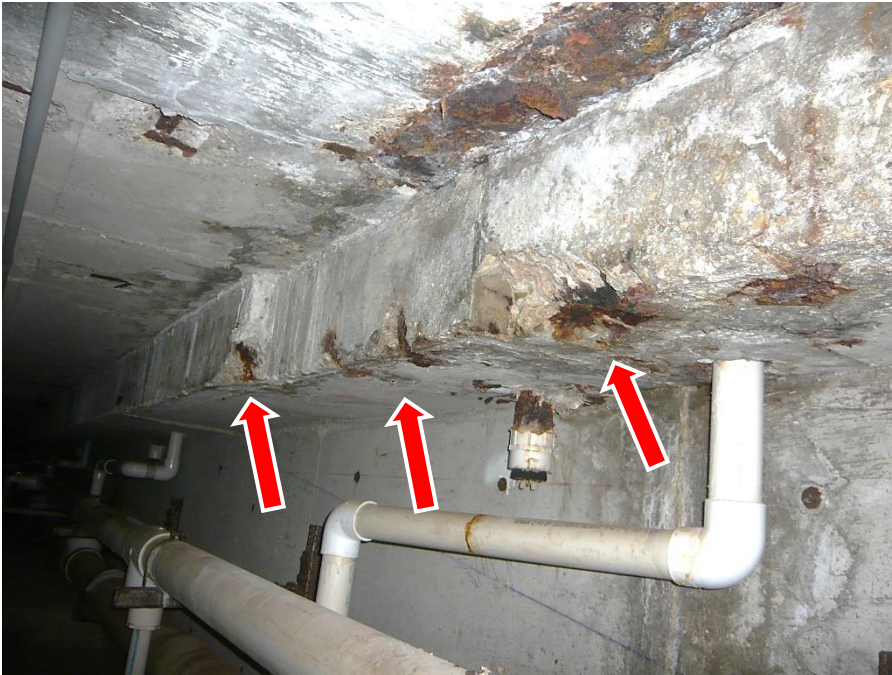
Figure 3: Spalled concrete, with exposed corroded steel reinforcement, on the underside and face of the portion of the pool wall that supports the pool deck slab

2. Repair deteriorated concrete at vertical surfaces of the pool and foundation walls. Repair procedure should be similar to that described for the floor slab repairs. For proper repairs to be performed, shoring will likely be required at many of the column repair locations

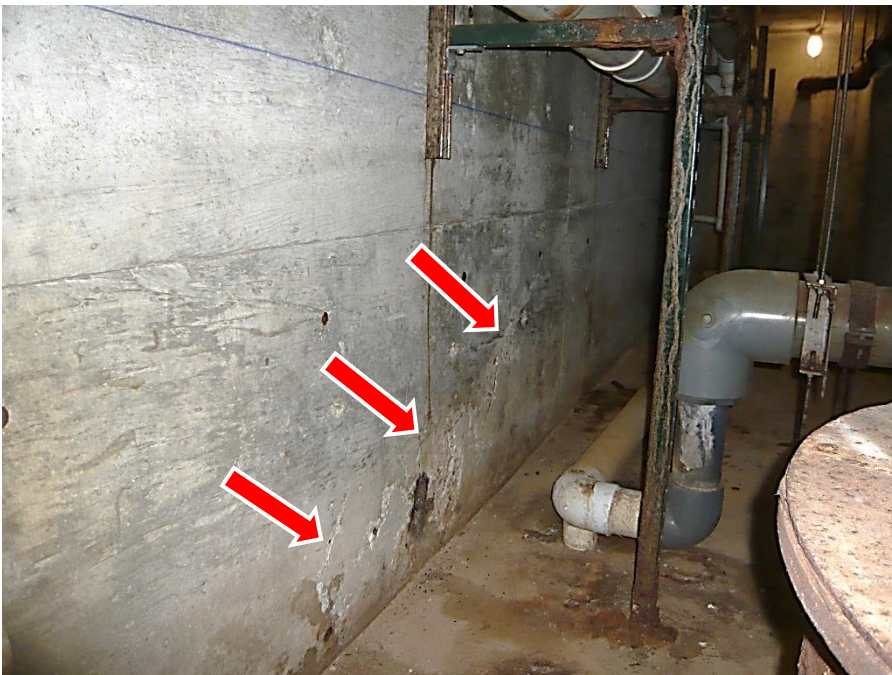
Figure 4: Incipient spall (loose concrete) at the base of the pool wall as observed along the north edge, near the west corner of the pool

1. Remove loose concrete from the underside of the concrete slabs and upper surfaces of walls throughout the tunnel structure to minimize potential falling hazards for personnel working under the pool deck. It is recommended that this work be performed by a qualified Contractor who specializes in concrete restoration. The Contractor performing the work should sound all overhead and vertical surfaces to help identify areas of deteriorated concrete to be removed.

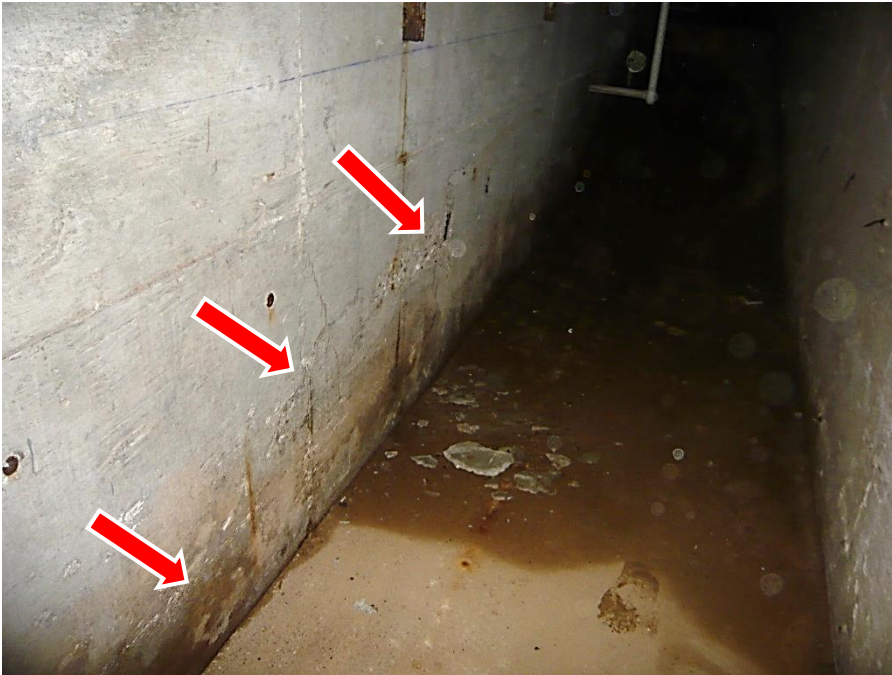
Figure 5: Incipient spall (loose concrete) at the base of the pool wall as observed near the center of the south edge of the pool

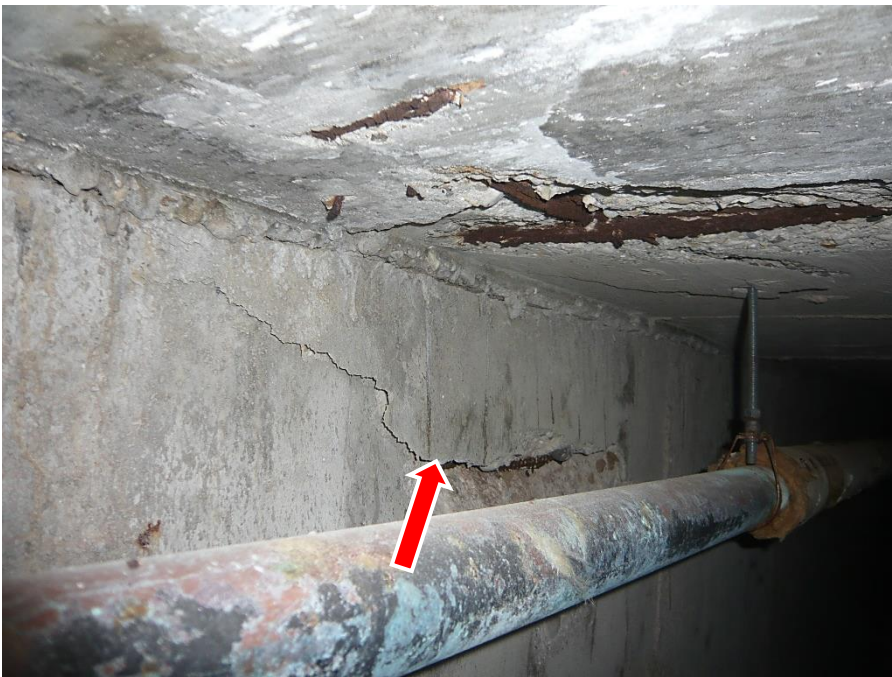
2. Areas of loose concrete (incipient spalls) exist at many locations of distress on the underside of the structural pool deck slab (Figures 6 and 7)
3. Corroded steel reinforcing bars exist at open spall locations on both the underside of the structural pool deck slab and vertical surfaces of the pool walls (Figure 8)

Figure 6: Incipient spall (loose overhead concrete) at the building foundation wall as observed near the center of the north edge of the pool. Note, spalled concrete with exposed steel reinforcement on the underside of the pool deck slab

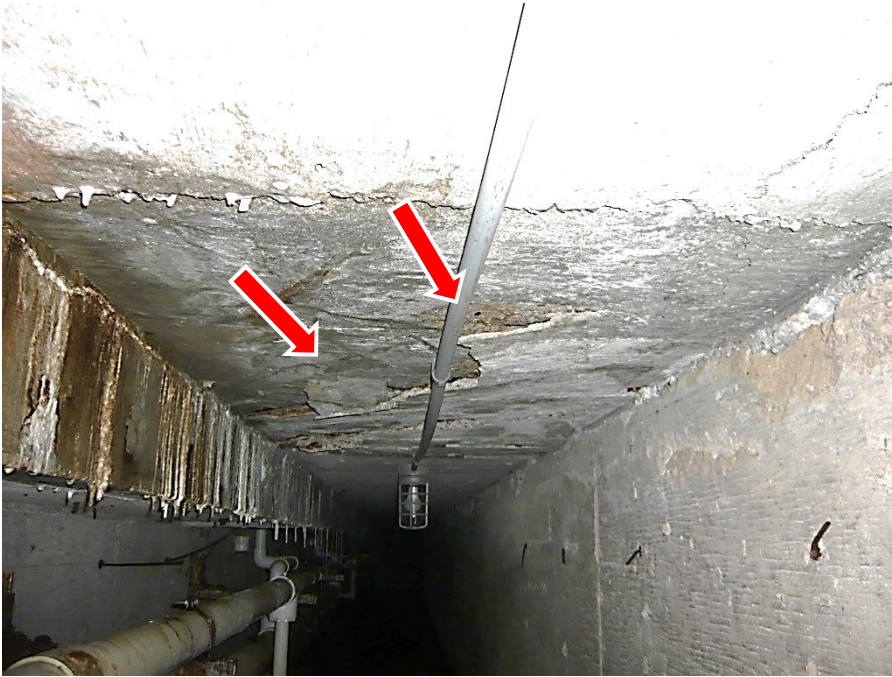
Figure 7: Incipient spall (loose overhead concrete) on the underside of the pool deck slab as observed along the south edge of the pool

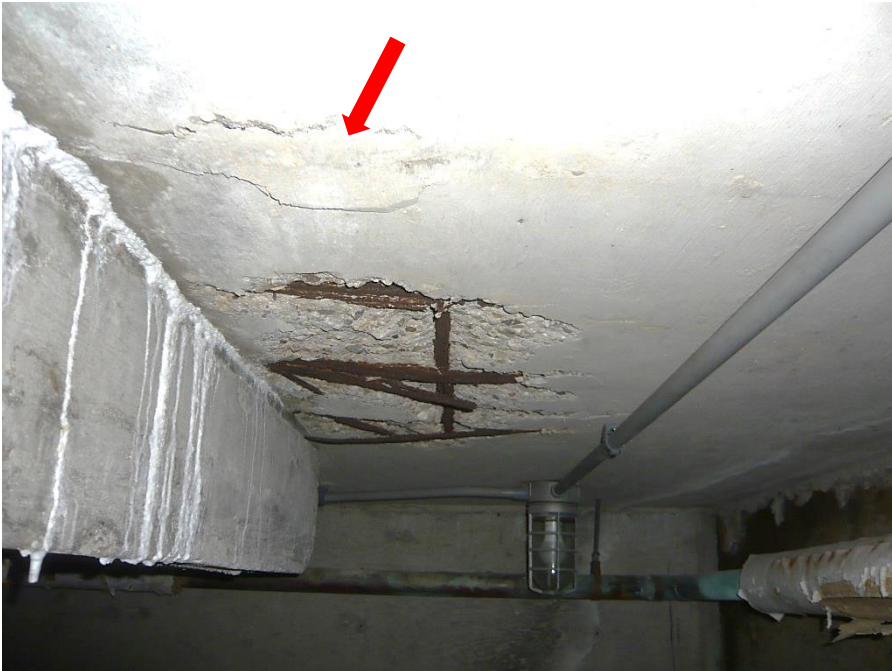
Corrosion of the reinforcing steel should be expected to continue and accelerate if conditions remain the same in the structure. Unmitigated corrosion of the embedded steel reinforcement has and will lead to a loss of cross-sectional area of the steel bars. Significant loss of cross-sectional area will reduce the strength of the steel section and reduce the load-carrying capacity of the concrete structure. Development of corrosion on embedded steel reinforcement can be mitigated by limiting water infiltration through the concrete floor slabs. Deterioration in the existing ceramic tile, including cracked tile and cracked and open grout joints, provide pathways for the chlorinated pool water to breach the waterproofing layer and infiltrate the pool deck slab through cracks and joints in the concrete. The extent of active water leaks and development of efflorescence at the pool deck to pool wall support interface suggests that the ceramic tile and grout particularly at the gutter are no longer effective in mitigating water infiltration through the pool deck.

Figure 8: Typical view of an open spall on the underside of the pool deck slab with exposed corroded steel reinforcement. Arrow indicates an incipient spall (loose overhead concrete) adjacent to the spall

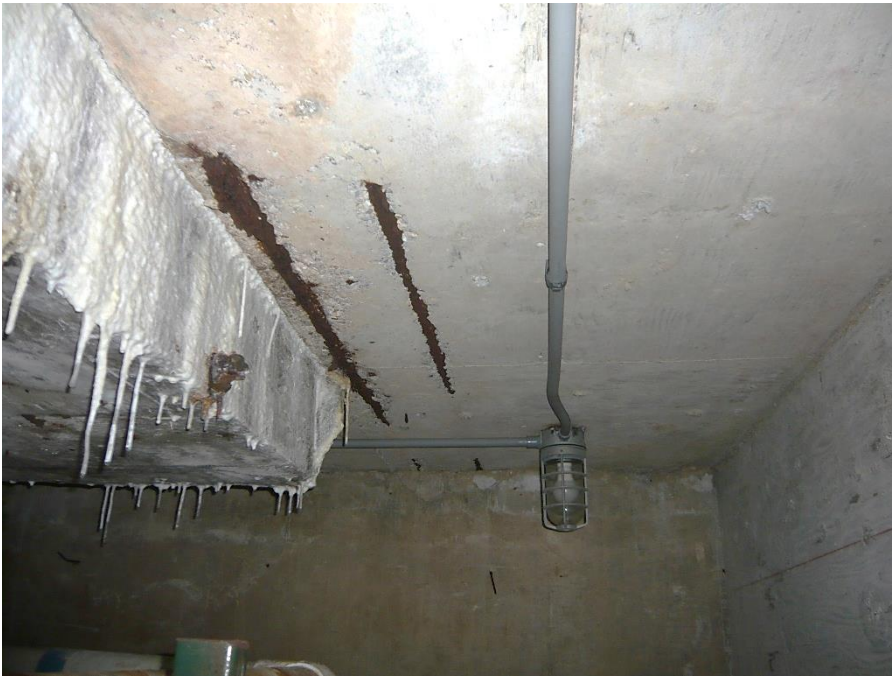
4. Exposed corroded steel reinforcing at the surface of the concrete on the underside of the slab exist at the northwest and southwest corners and near the center of the north edge of the pool (Figure 9). Sounding areas directly adjacent to the exposed reinforcing bars did not indicate areas of delaminated or unsound concrete

Figure 9: View of corroded steel reinforcement placed at the bottom surface of the pool deck slab. Sounding of adjacent areas did not indicate areas of unsound concrete

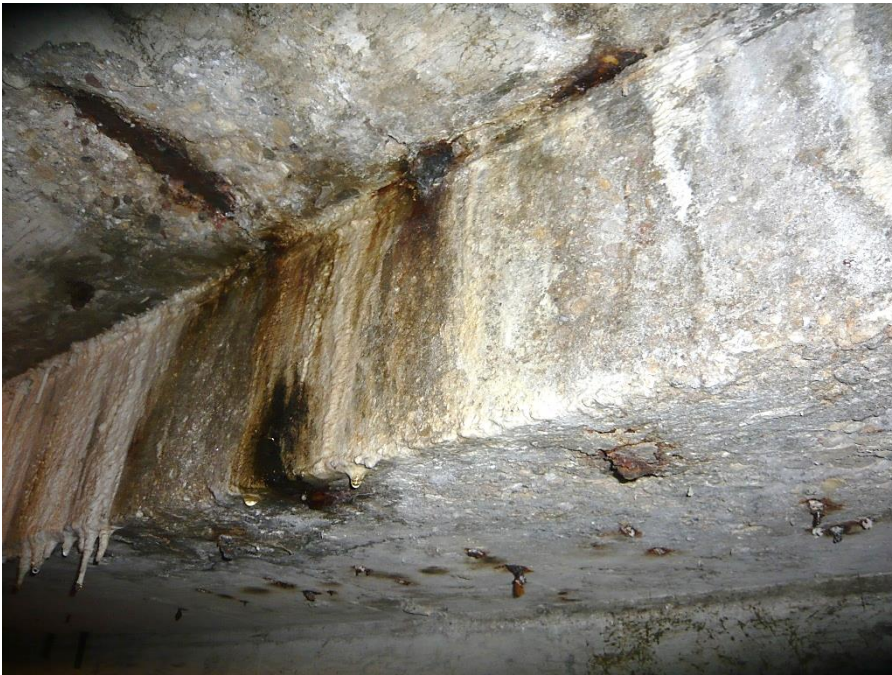
5. Active water leaks exist throughout the pool structure. Active water leaks generally appear to occur at the joint between the integrally formed gutter around the perimeter of the concrete pool structure and the concrete slab that forms the deck surrounding the pool (Figure 10)

Figure 10: View of active water leak and efflorescence staining at the slab to pool wall support interface.

3. Consideration could also be given to injecting cracks and joints, at the integrally formed gutter around the perimeter of the concrete pool structure and the concrete slab that forms the deck, with polyurethane grout or epoxy. This crack injection repair should be performed in conjunction with top surface waterproofing repairs. Depending on the extent and quality of injection repairs, they may provide an additional layer of protection against water infiltration through the slab. If top surface waterproofing repairs are not performed, and injection repairs do not properly fill cracks and joints, this type of repair could trap water within the slab leading to further concrete deterioration.

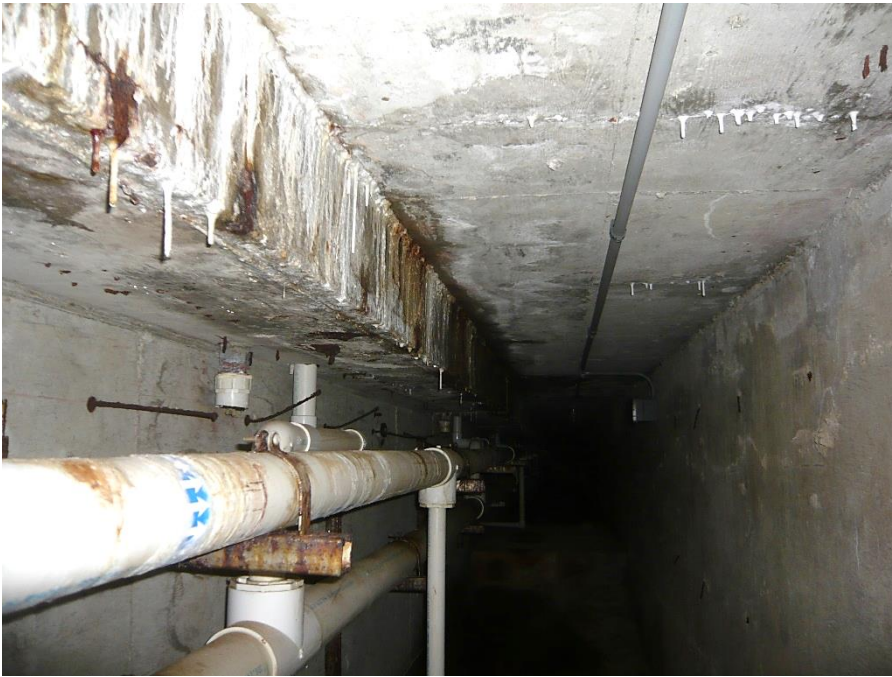
- a. Additional signs of previous or active water leakage, e.g. efflorescence, exist around the perimeter of the pool deck structure (Figure 11)
 - b. Standing water, at an active water leak, exists at the southeast corner of the pool (Photo 12)

Figure 11: Typical view of efflorescence staining (white mineral deposits), an indication of previous and/or active water infiltration, along the length of the slab to pool wall support interface.

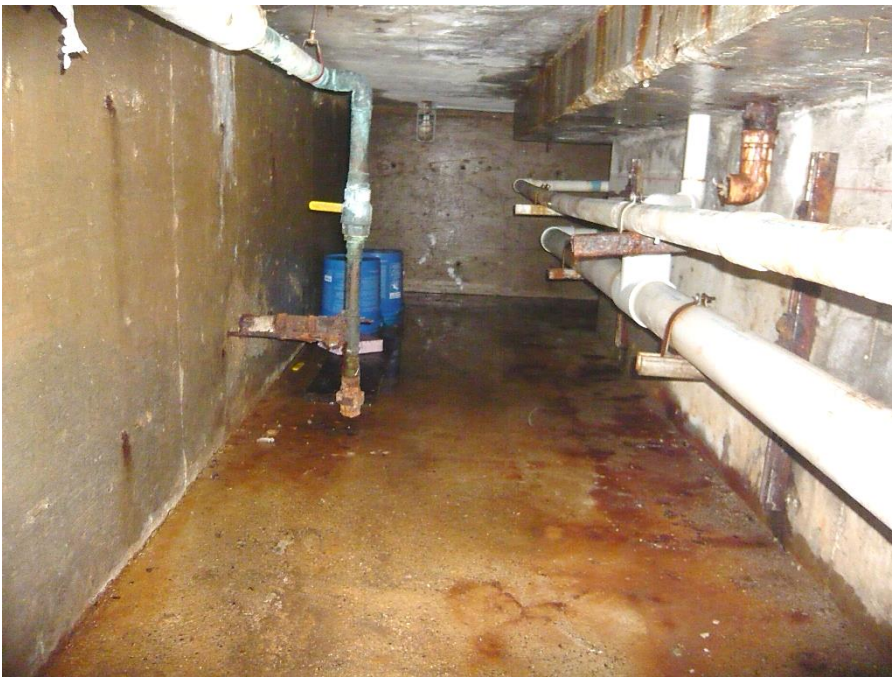
Figure 12: Standing water on the tunnel floor slab at an area of an active water leak as observed at the southwest corner of the pool

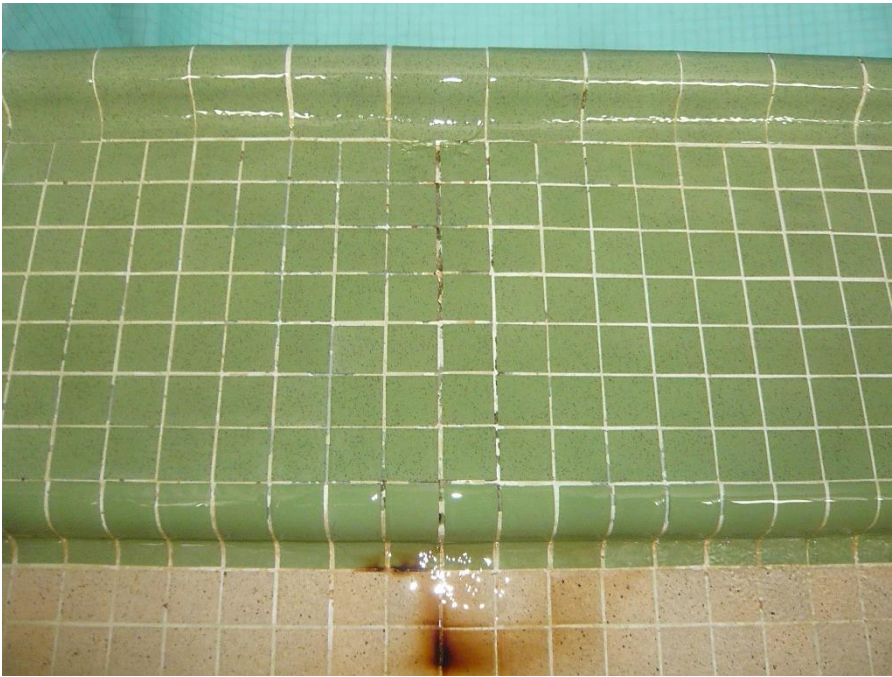
6. Isolated areas of deterioration exist throughout the ceramic tile on the top surface of the pool deck. Observed deterioration typically included cracked and open grout joints and cracked tile (Photos 13 and 14)

Figure 13: Cracked and deteriorated grout joints in the ceramic tile gutter as observed near the southwest corner of the pool

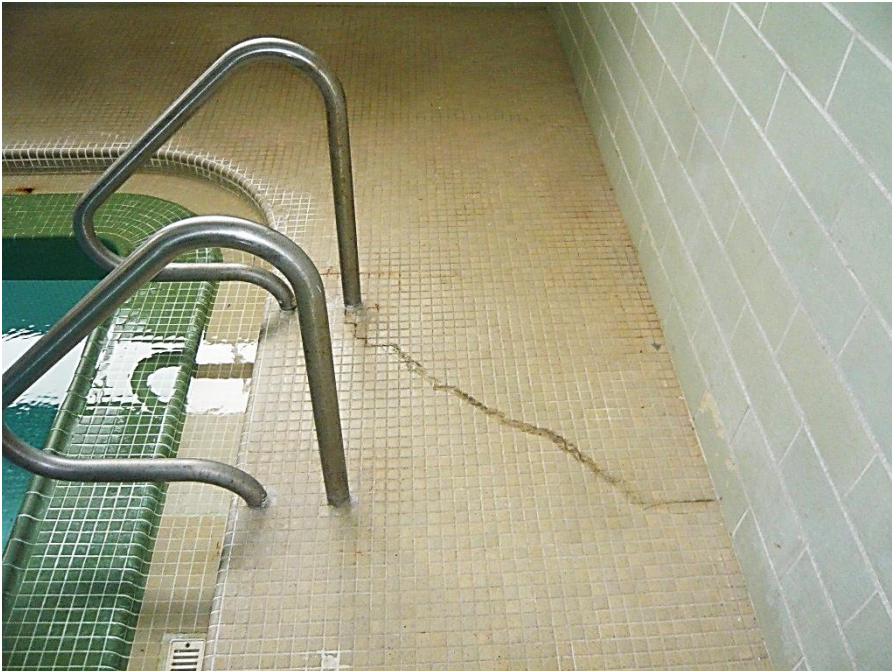
Figure 14: Cracked tile and grout joints, previously filled with a caulk material, as observed near the southwest corner of the pool

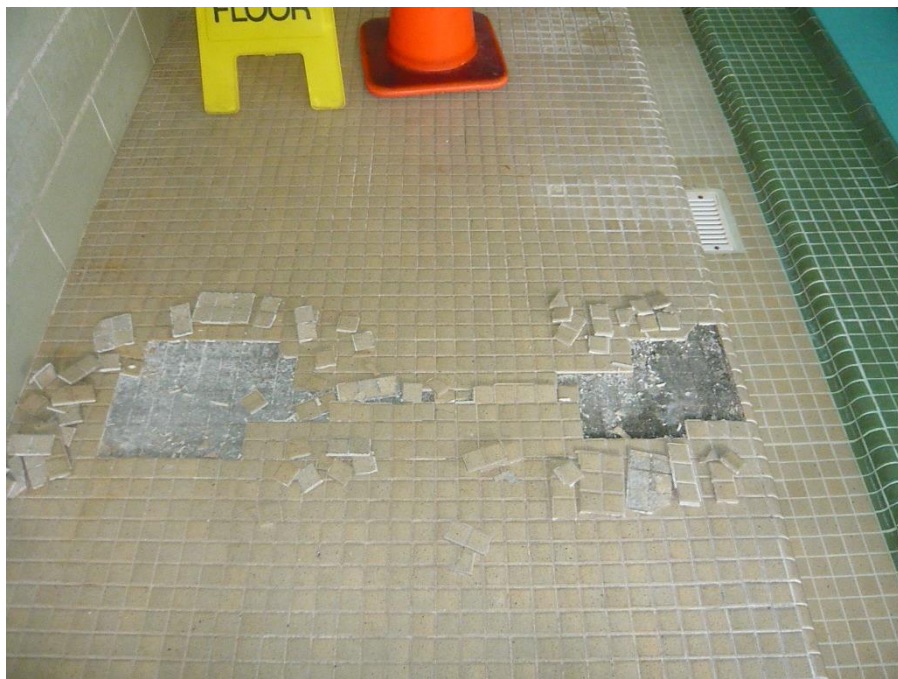
Figure 15: *Debonded tile near the southwest corner of the pool. No unsound concrete was visually observed or detected via hammer sounding where exposed*
