FACILITIES ASSESSMENT REPORT - VOL. 2

04.24.19

FORT ATKINSON MIDDLE SCHOOL

Re: Fort Atkinson Middle School
Follow-up Structural Condition Assessment of
Existing Concrete Pool Structure
AE Project No. 018-492

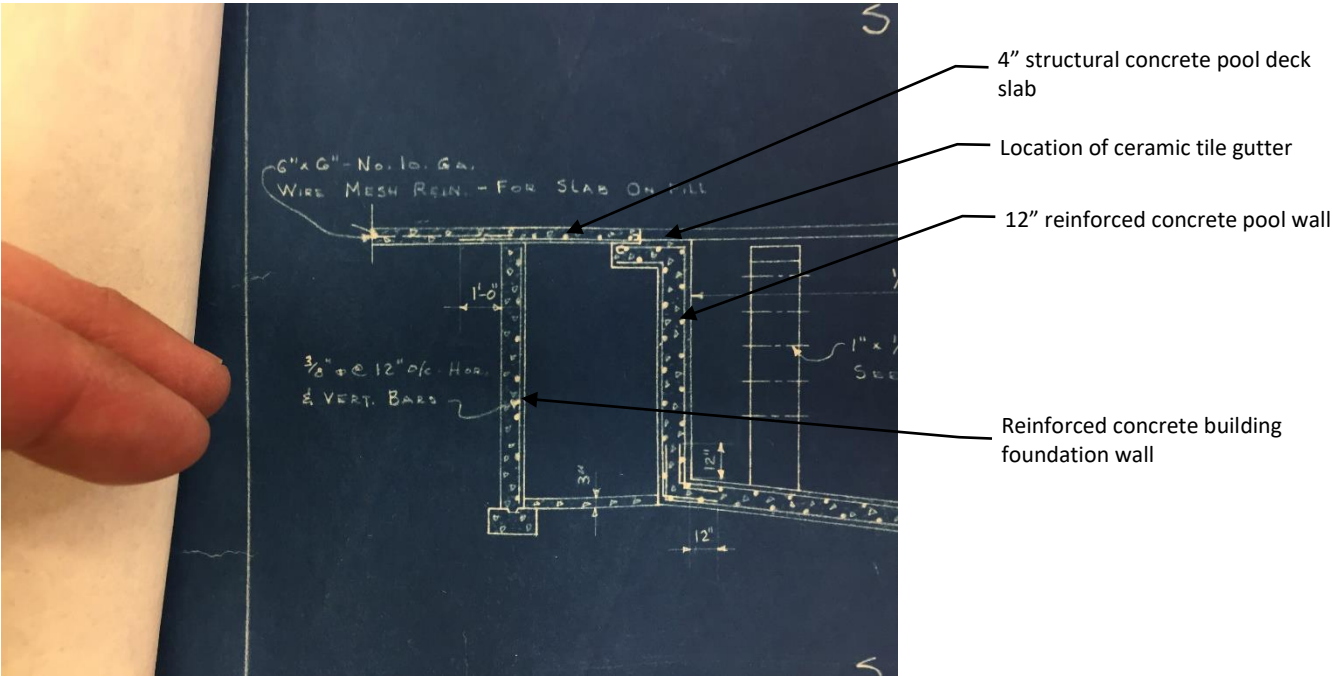
Figure 1: Typical cross-section through the reinforced concrete mechanical tunnel around the perimeter of the pool as excerpted from the original design drawings prepared by Foeller, Schober, Berners, Safford, and Jahn Architects dated 1957
